Bilateral fracture of prostheses post-hip replacement

SUMMARY

Fracture of hip prostheses is a rare occurrence. A case of bilateral hip prostheses fracture is described here. The need to follow-up and remain vigilant post hip replacement is highlighted.

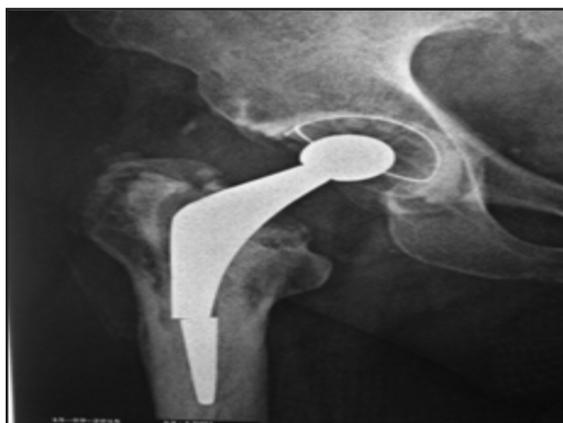
He presented in October 2015 with a history of right knee pain of one week duration. There was no history of trauma or fall. He was examined and the x-rays showed a fracture of the stem in the middle third of his right total hip replacement (Figure 1). He underwent surgery where a revision of the femoral stem was done through the previous surgical scar. The acetabular component was not affected during surgery and on X-ray and thus was not replaced. Post-operatively he developed a superficial wound infection which settled with wound debridement and antibiotics. He was discharged home well after a week. The whole episode however made him weary and anxious and he started to question the stability of the other prostheses.

Fig. 1: Right Prostheses fracture on X-ray.

X-rays done preoperatively for both prosthesis fractures showed radiolucent shadows between the femoral stem and the cement indicating loosening at the level of the calcar. Both implants were fractured in the middle third of the stem and had burnishing marks on them.

Failure of the implants took place at 13 and 14 years respectively. After his initial hip replacements, the patient did not have a very active life style. Both the arthroplasties were cemented and both stems showed signs of burnishing which may be due to loosening.

A possible reason why the implants failed includes loosening of the implant itself. Prosthesis fracture at the point where the distal stem is well fixed and the proximal stem unsupported,

due to wear of the cement at the cement-implant interface was common with the early Charnley prostheses.² Prosthesis modification and the introduction of Orthron 90 (DePuy, Warsaw, Ind.) have tried to eliminate this mode of failure.²

This highlights the importance to ensure adequate cement mantle in Gruen zones 1 and 7 as failure to do so, may result in micro motion and subsequent stem fracture irrespective of the metal used. Gruen zones are descriptive of seven zones of cement mantle around the stem. When there is loosening proximally and a firm fixation distally it can lead to failure of the implant or chronic instability.³ In this case the implant, which is a cobalt chrome implant, had failed.

Another postulate for implant failure is metal fatigue as both the femoral stems failed within one month of each other. To verify this would have required the services of a metallurgist which we did not have. Other possibilities of failure are defect in design and weight gain. Gait also may pose an influence, as most people who have bilateral hip replacement done via posterior approach tend to have some weakness of the gluteal muscles which may cause abductor weakness leading to chronic instability.⁴ The replacement had also been done before the age of 50 and this may contribute to a higher risk of failure of prosthesis survival due to axial loading of the femoral component.⁵

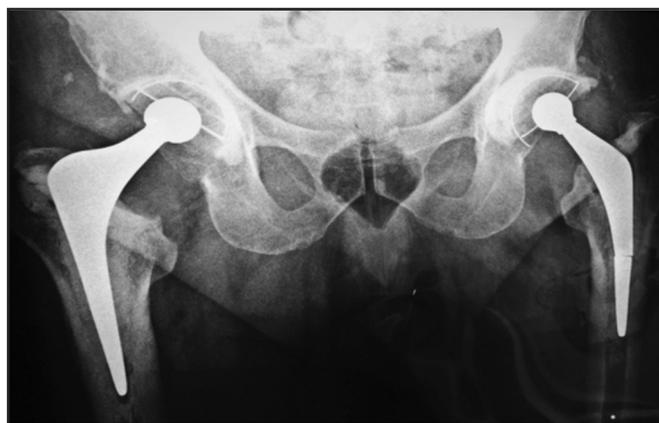
A month after his discharge he was unable to get out of bed and had to be taken to the hospital on a wheelchair due to pain and weakness of his left hip. Again, there was no history of trauma or fall. X-rays done showed fracture of the left femoral implant (Figure 2). This was again revised in the same way as the first with no post-operative complications. Both instances of fracture occurred spontaneously.

Fig. 2: Left Prostheses fracture on X-ray.
